# Navajo Abandoned Uranium Mine

# Site Screen Report

Mine Name: Claim 10 Mine ID: 807

August 2011

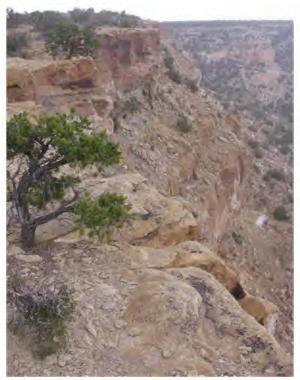
Photo 1: Mine Site #807; Cliff area

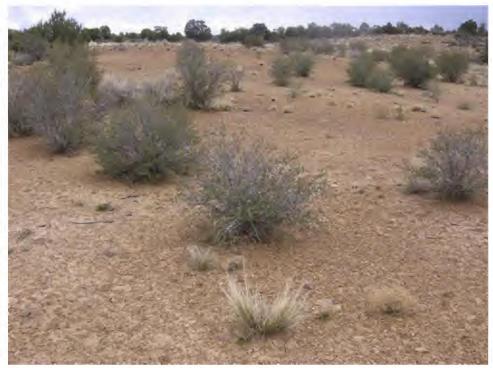
Reclamation cap, 200' diameter, center of site, red sandy clay

Photo 2: Mine Site #807; Reclamation area
